FIRE PERFORMANCE EVALUATION OF AN
ALUMINUM COMPOSITE MATERIAL PANEL
WALL ASSEMBLY IN GENERAL ACCORDANCE
WITH ASTM E 119, *STANDARD TEST METHODS
FOR FIRE TESTS OF BUILDING CONSTRUCTION
AND MATERIALS*

SwRI® Project No. 01.12694.01.307
Test Completion Date: January 10, 2007
Report Date: January 30, 2007

Alubond
Eurocon Building Industries
P.O. Box 4819
Ajman Freezone, AJMAN
U.A.E.

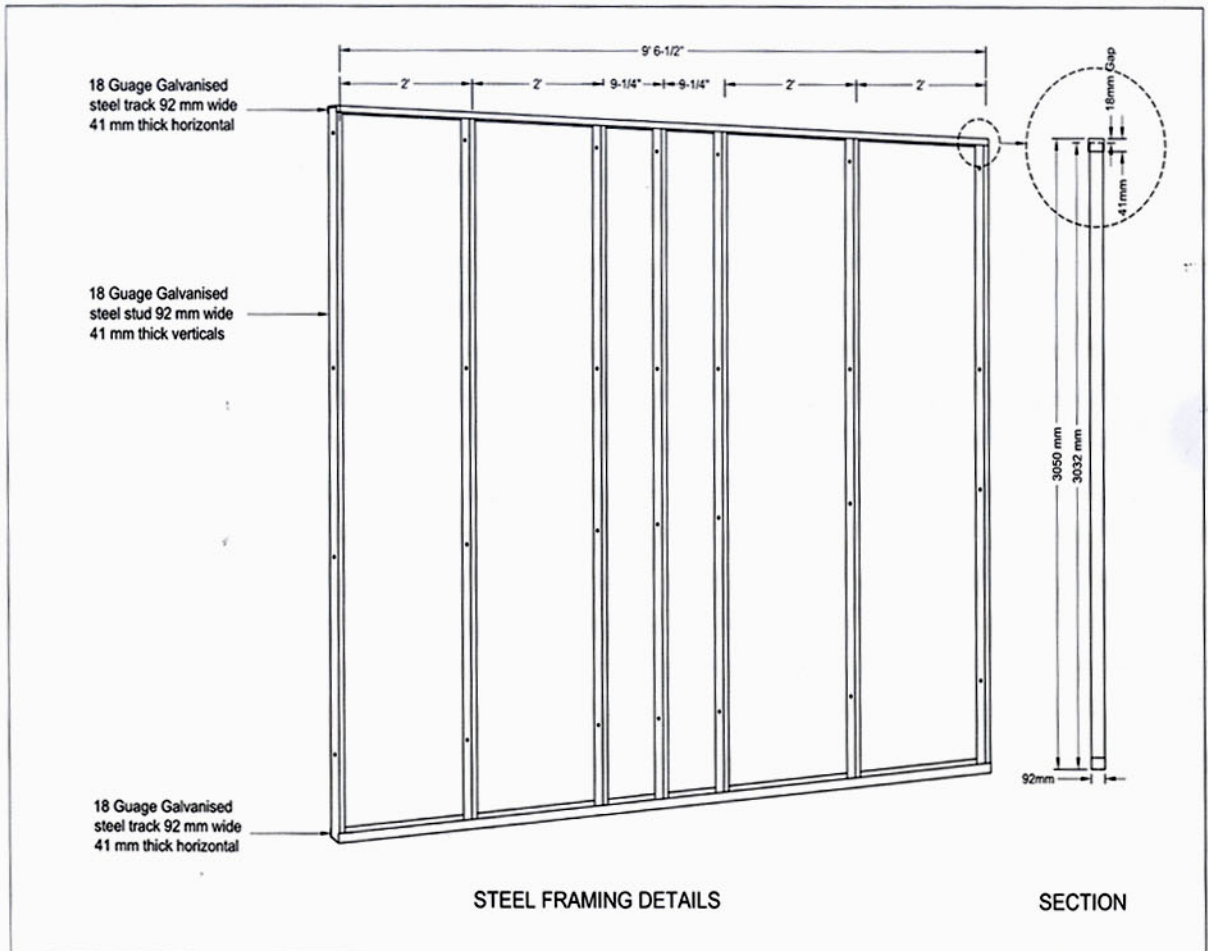
Figure A-1. Steel Stud Details.

All of the Client-supplied drawings are presented in Appendix A. Select photographs are provided in Appendix B. Temperature data is provided in Appendix C. Video documentation and photographs taken during the test accompany this report as enclosures on DVD and compact disc, respectively, and are considered part of this report.

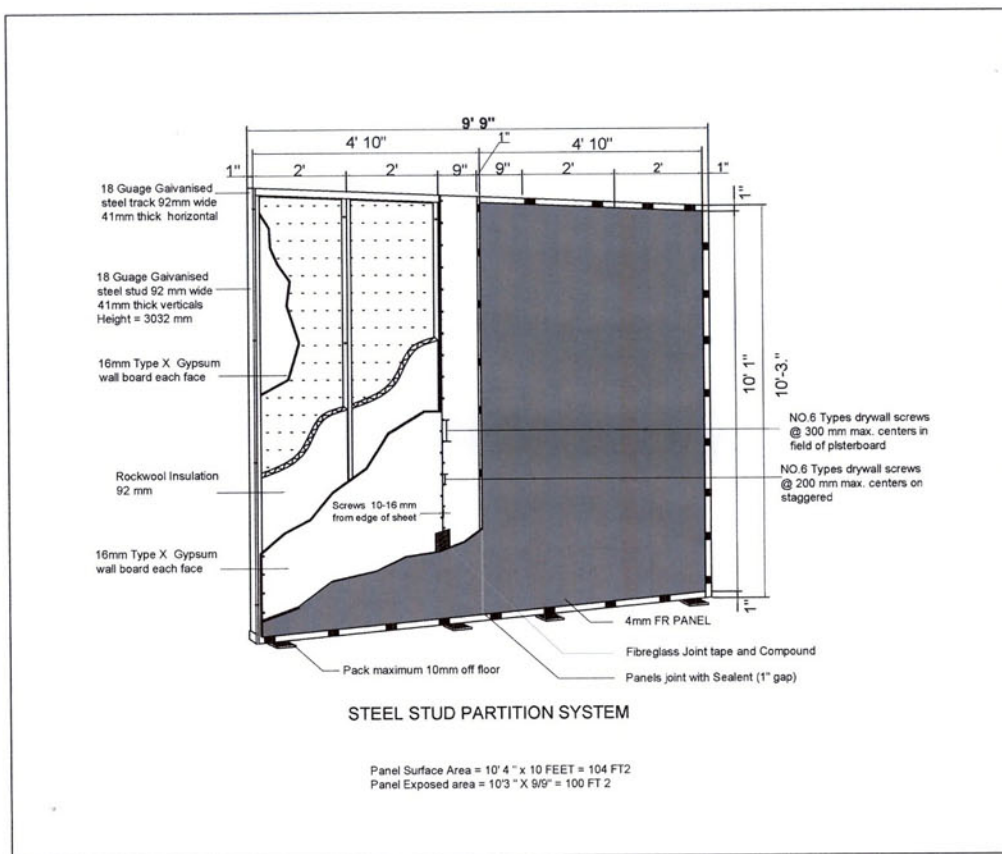
Figure A-2. Wall Details.

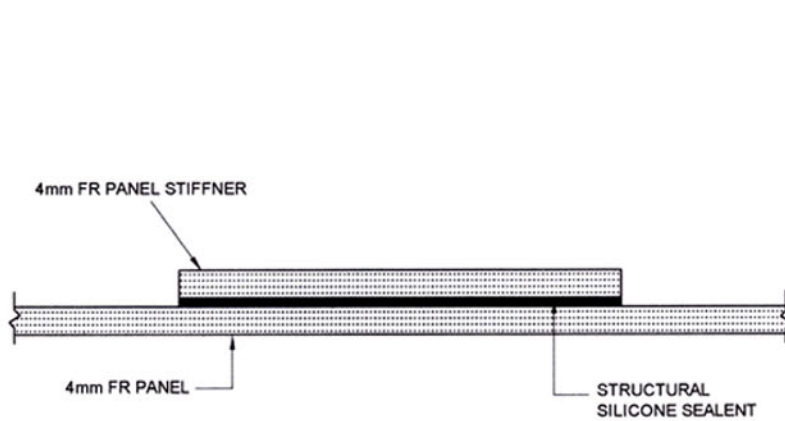
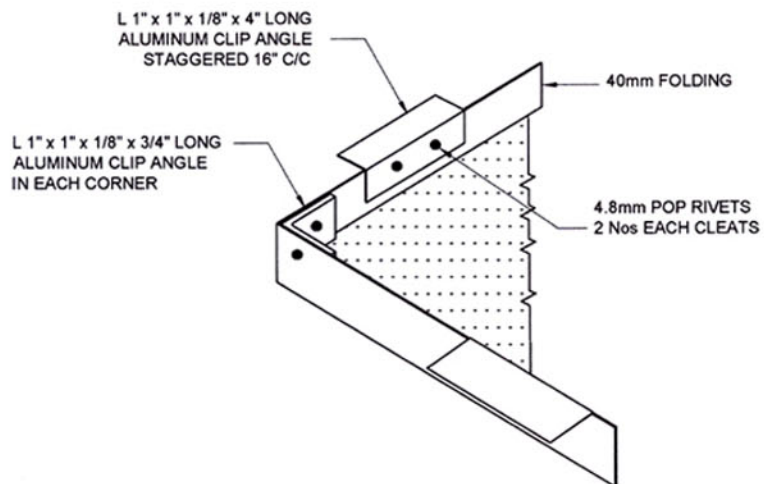
SECTION A-A
Figure (1*)
ROUT AND RETURN CLIP SYSTEM

Figure (2*)
CORNER BRACE & CLEATS DETAILS

Figure A-3. Stiffener and Bracket Details.

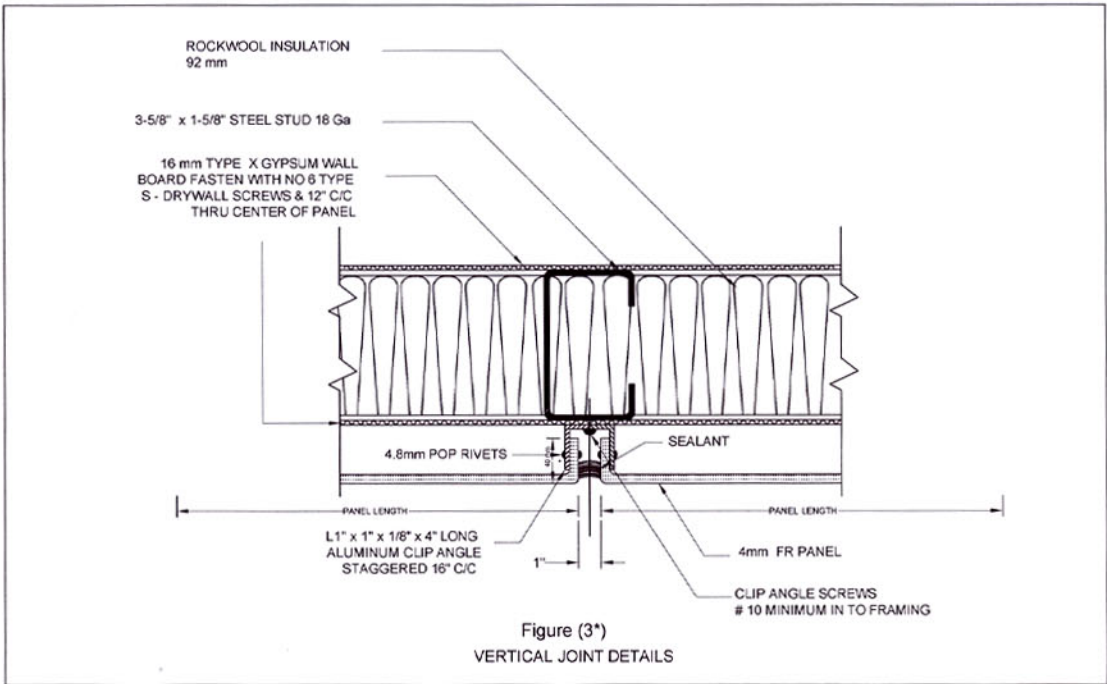
Figure A-4. Bracket Installation Details.

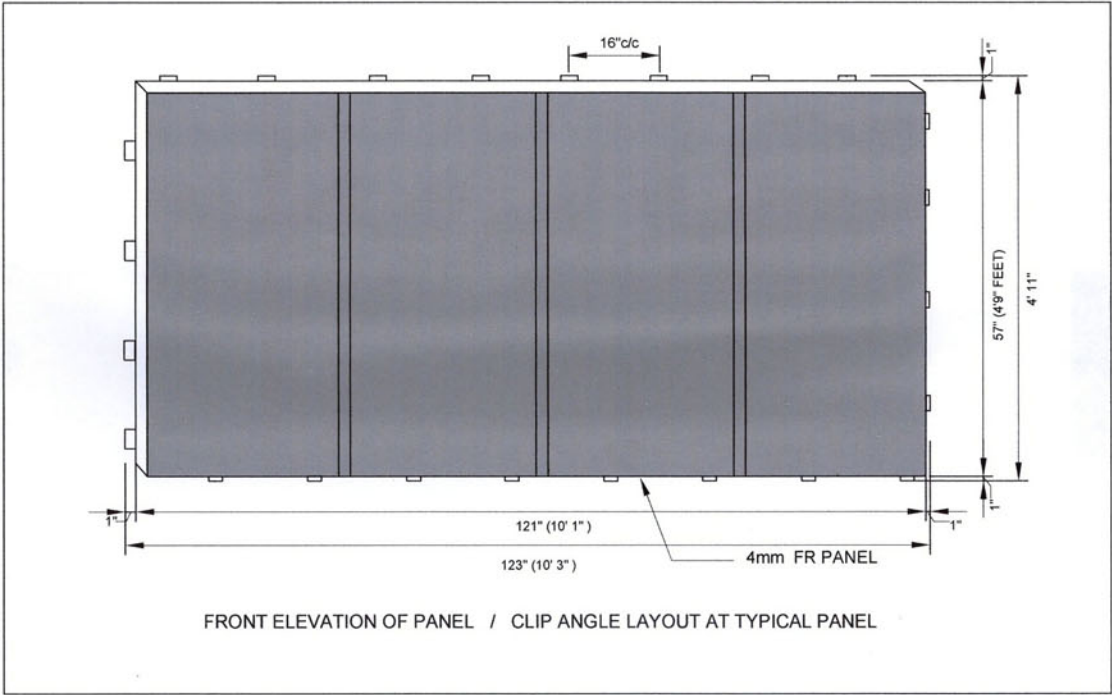
Figure A-5. ACP Details and Installation Brackets.

SwRI received two ACP panels, identified by the Client as “Alubond U.S.A. FR Aluminum Composite Panel,” on January 10, 2007. The panels were “route and return” on all sides, 10 ft 3 in long, 4 ft 10 in. wide, and 0.157 in. thick with 1 × 1 in L angle cleats. The panels are coated with a PVDF, flouropolymer, or polyester on the front surface and polyester on the back skin. The composite panels were prepared in the form of a tray with 1-½-in. lips. Each composite panel was insulated with 1-½-in. thick 8-lb/ft³, Delta-8, mineral wool board insulation manufactured by Rock Wool Manufacturing Company, located in Leeds, AL. Aluminum L-shaped angles measuring 1 × 1 × ¼ × 4 in. long were attached, along the perimeter of the tray, 16-in. apart. The angle clips were staggered to avoid overlapping during the installation onto the exposed surface. The ACP panels were fastened to the exposed face of the wall with No. 6, 1-¼-in. Type S screws spaced 16 in. on center around the perimeter and joints and within the field.

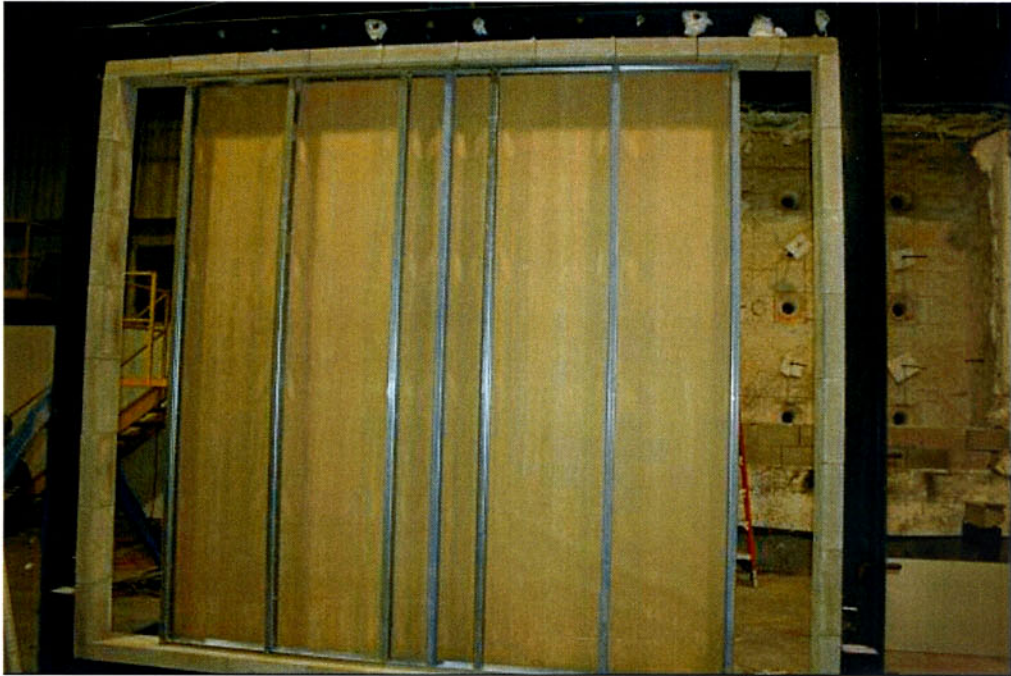
Figure B-1. Wall Construction in Progress.

SwRI personnel constructed a wall assembly with a nominal area of 100 ft² by utilizing 18-ga, 3-⁵/₈-in. corrosion resistant steel C-channel studs framed 24 in. on center on both sides. To accommodate the installation of the composite panels, three studs in the middle of the wall were spaced 9-¹/₄ in. on center. The wall was insulated with 3-¹/₂-in. thick, 8-lb/ft³, Delta-8, mineral wool board insulation manufactured by Rock Wool Manufacturing Company, located in Leeds, AL. One layer of ⁵/₈-in. thick Type "X" gypsum wallboard was used on both sides of the wall. The joints of the gypsum wallboard were staggered from the exposed and unexposed sides. The gypsum wallboard was mechanically fastened with No. 6, 1-¹/₄-in. Type S screws spaced 8 in. on center around the perimeter and joints, and 12 in. on center within the field. The gypsum wallboard on both sides were taped and treated with joint compound. The exposed fastener heads were also covered with joint compound.

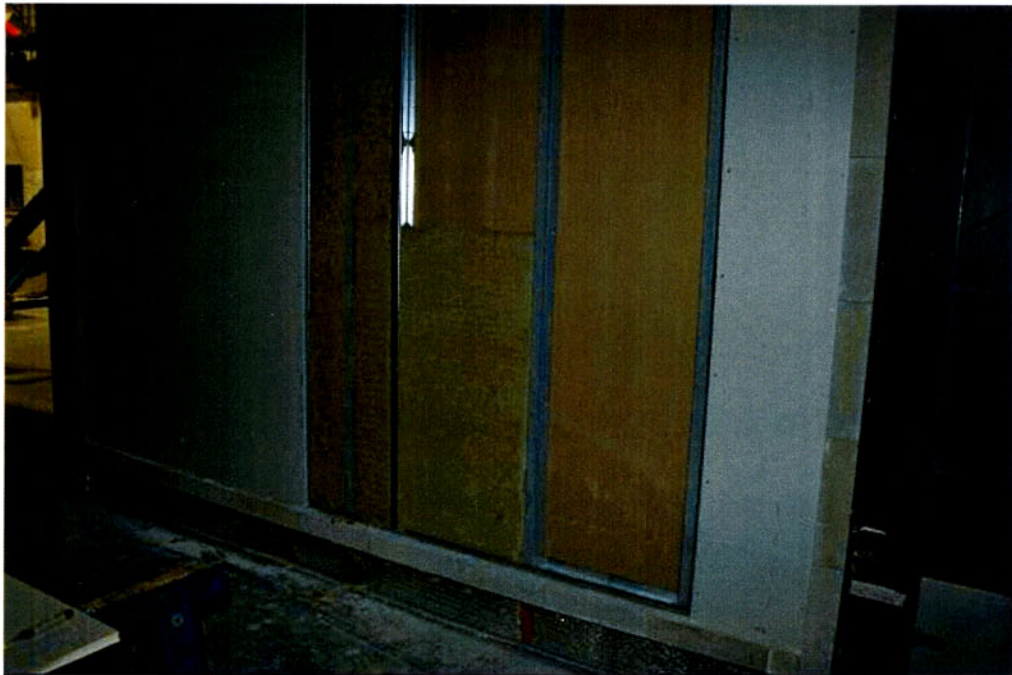
Figure B-2. Wall Construction With Insulation Boards Being Installed.

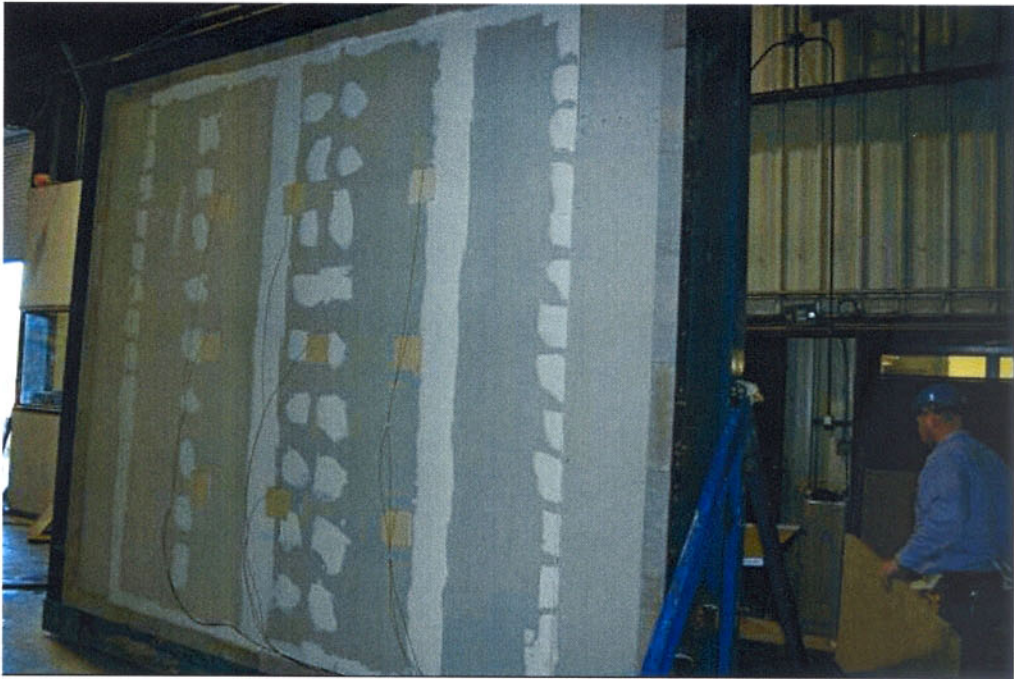
Figure B-3. Unexposed Side of the Wall With Instrumentation is Completed.

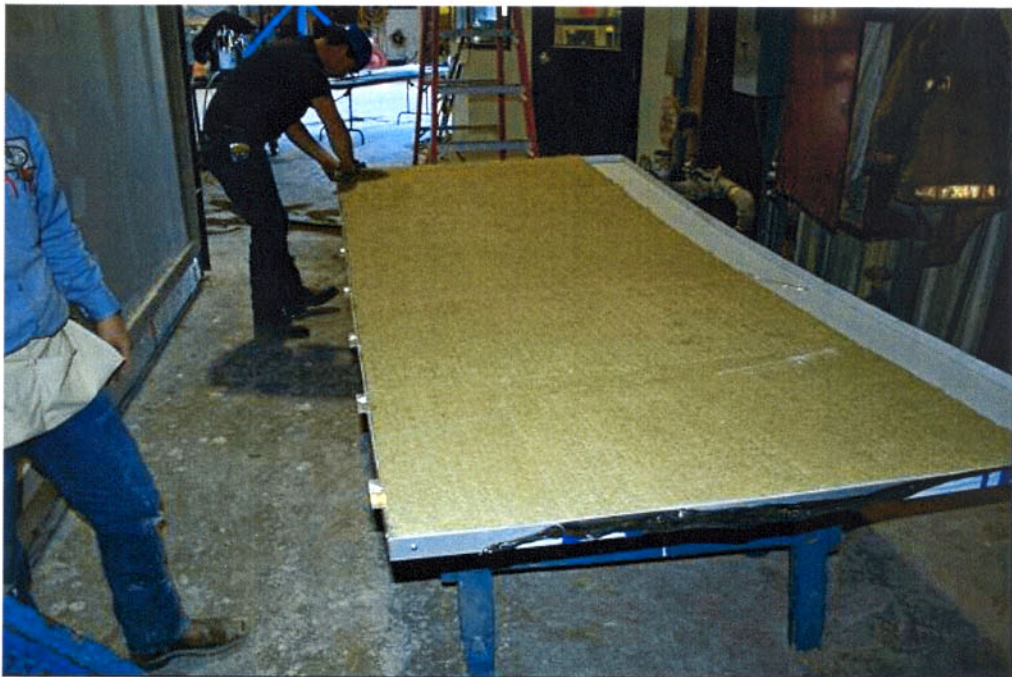
Figure B-4. ACP Panel Insulation in Progress.

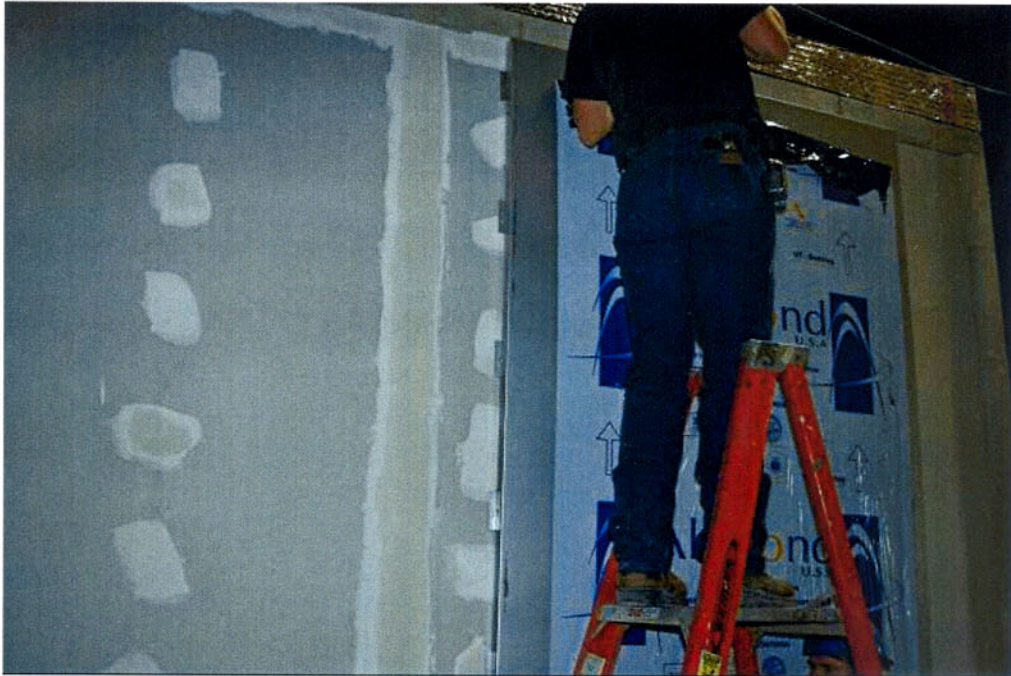
Figure B-5. ACP Panels Being Installed on the Exposed Face of the Wall.

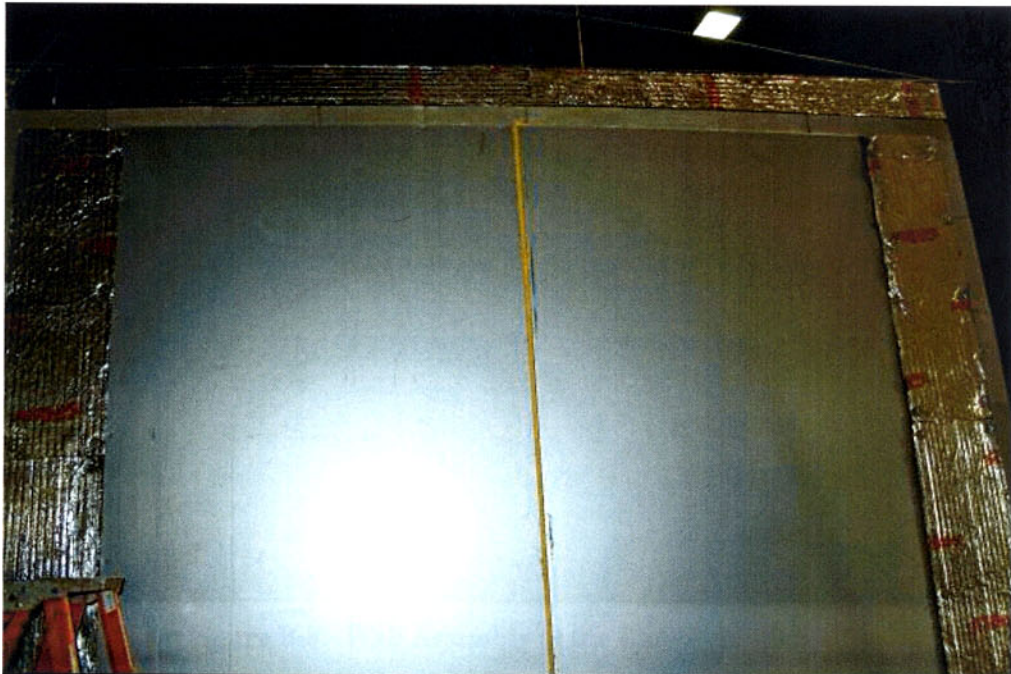
Figure B-6. ACP Panel Installation Completed. Joints Filled With Fire-Rated Caulk.

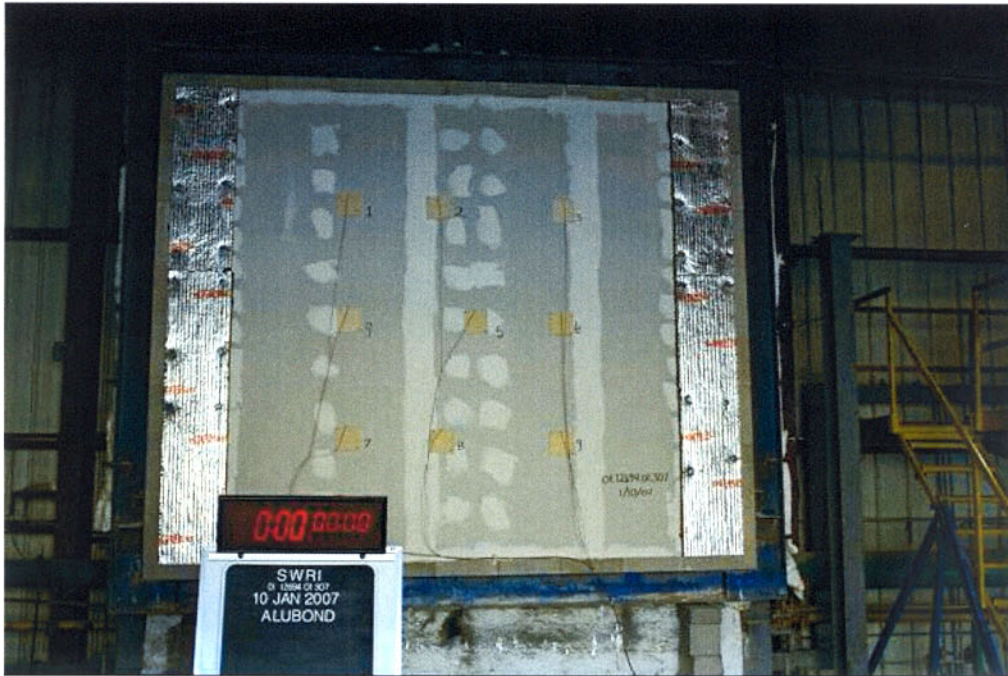
Figure B-7. Wall Assembly at the Start of the Test.

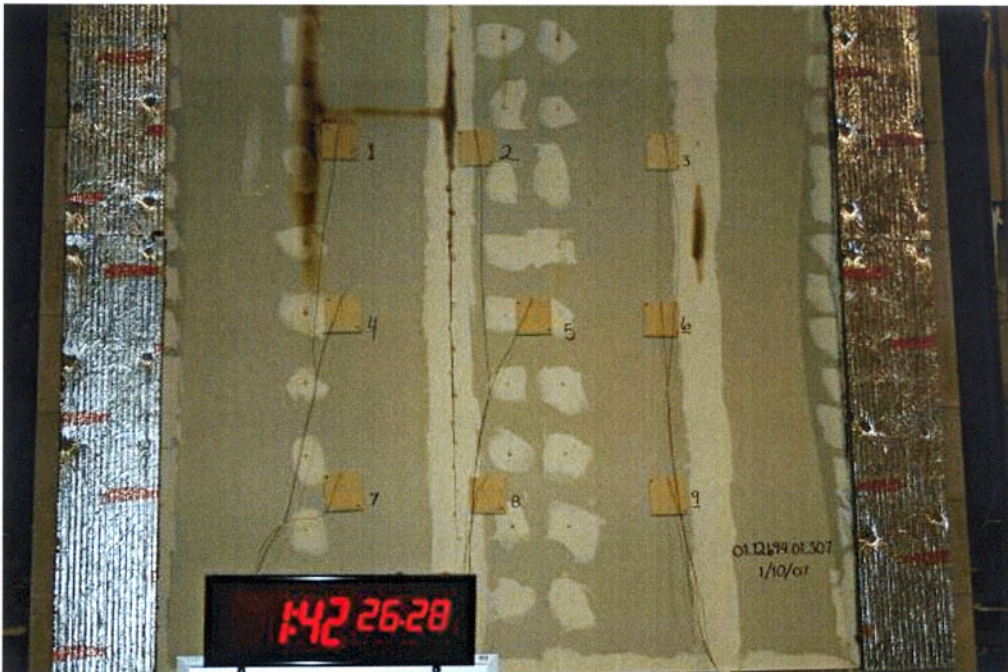
Figure B-8. Wall Assembly at the End of the Test.

TIME Min:Sec	OBSERVATIONS
0:00	Start of test.
30:00	Light smoke along top perimeter.
45:00	Light smoke along right edge.
62:00	Inward bowing. No discoloration on the unexposed side.
88:00	Discoloration of gypsum wallboard on the left hand side of the wall.
94:00	Discoloration of gypsum wallboard at center of the wall.
102:23	Maximum single point temperature exceeded. Test Terminated.
104:00	End of test. Hose stream test was not conducted.
Post Test	ACM panels totally consumed. Steel studs warped and bowed. Gypsum wallboard intact.

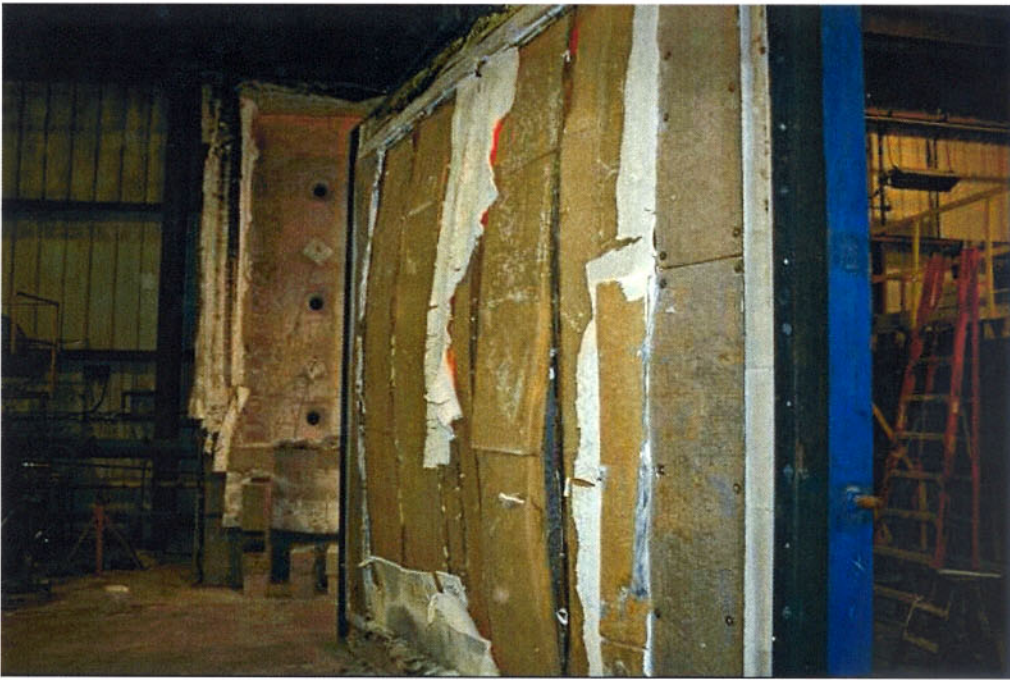
Figure B-9. Exposed Side of Wall Assembly After the Fire Test.

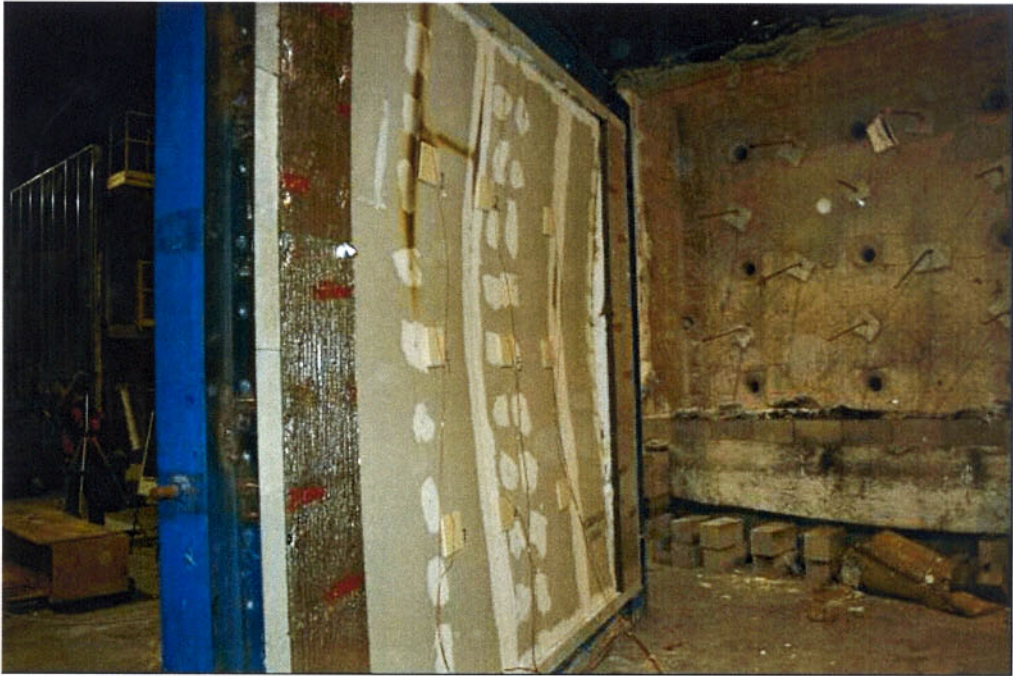
Figure B-10. Unexposed Side of Wall Assembly After the Fire Test.

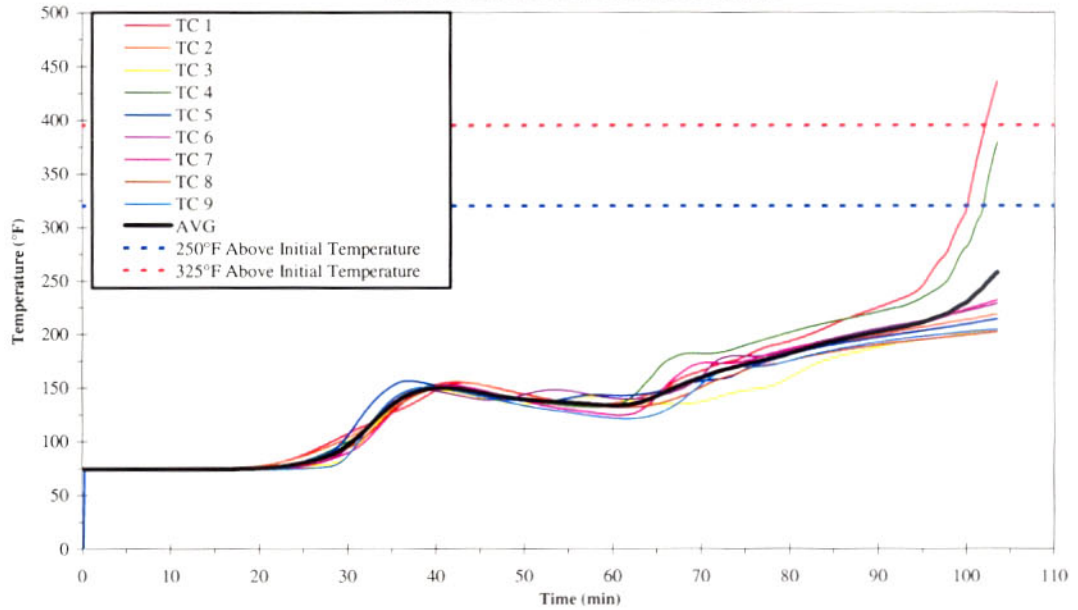
Client: Alubond
SwRI Project No.: 01.12694.01.307
Test Date: January 10, 2007
Test ID: 07-010Alu1.csv

UNEXPOSED FACE THERMOCOUPLES

The wall system, as described in this report, **passed** the temperature requirements of ASTM E 119 for 1 hr and 42 min duration of the fire-rating test without passage of flame or gases hot enough to ignite the cotton waste, per Section 18.1.1 of the Standard.

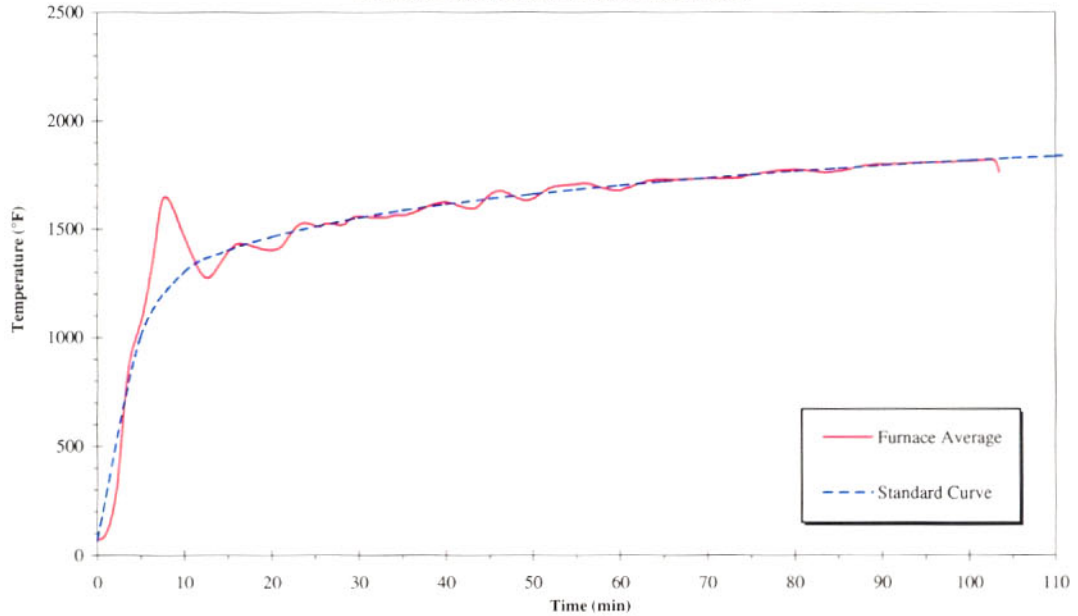
Client: Alubond
SwRI Project No.: 01.12694.01.307
Test Date: January 10, 2007
Test ID: 07-010Alu1.csv

FURNACE AVERAGE TEMPERATURE

The test was completed on January 10, 2007. The wall assembly was mounted to SwRI’s large-vertical furnace with the ACP panels exposed to the furnace environment and all instrumentation connections were verified. The wall assembly was exposed to the standard temperature-time curve specified in ASTM E 119. Unexposed side temperatures and furnace temperature data for the tests are contained in Appendix C. The ambient temperature and relative humidity at the time of the test were 70°F and 67 percent, respectively. Visual observations are presented in Table 1.
